# Solid Waste Management Unit 4 – Sludge Lagoon Closure Construction Certification Report

Prepared for

**ArvinMeritor**<sup>™</sup>

March 3, 2011

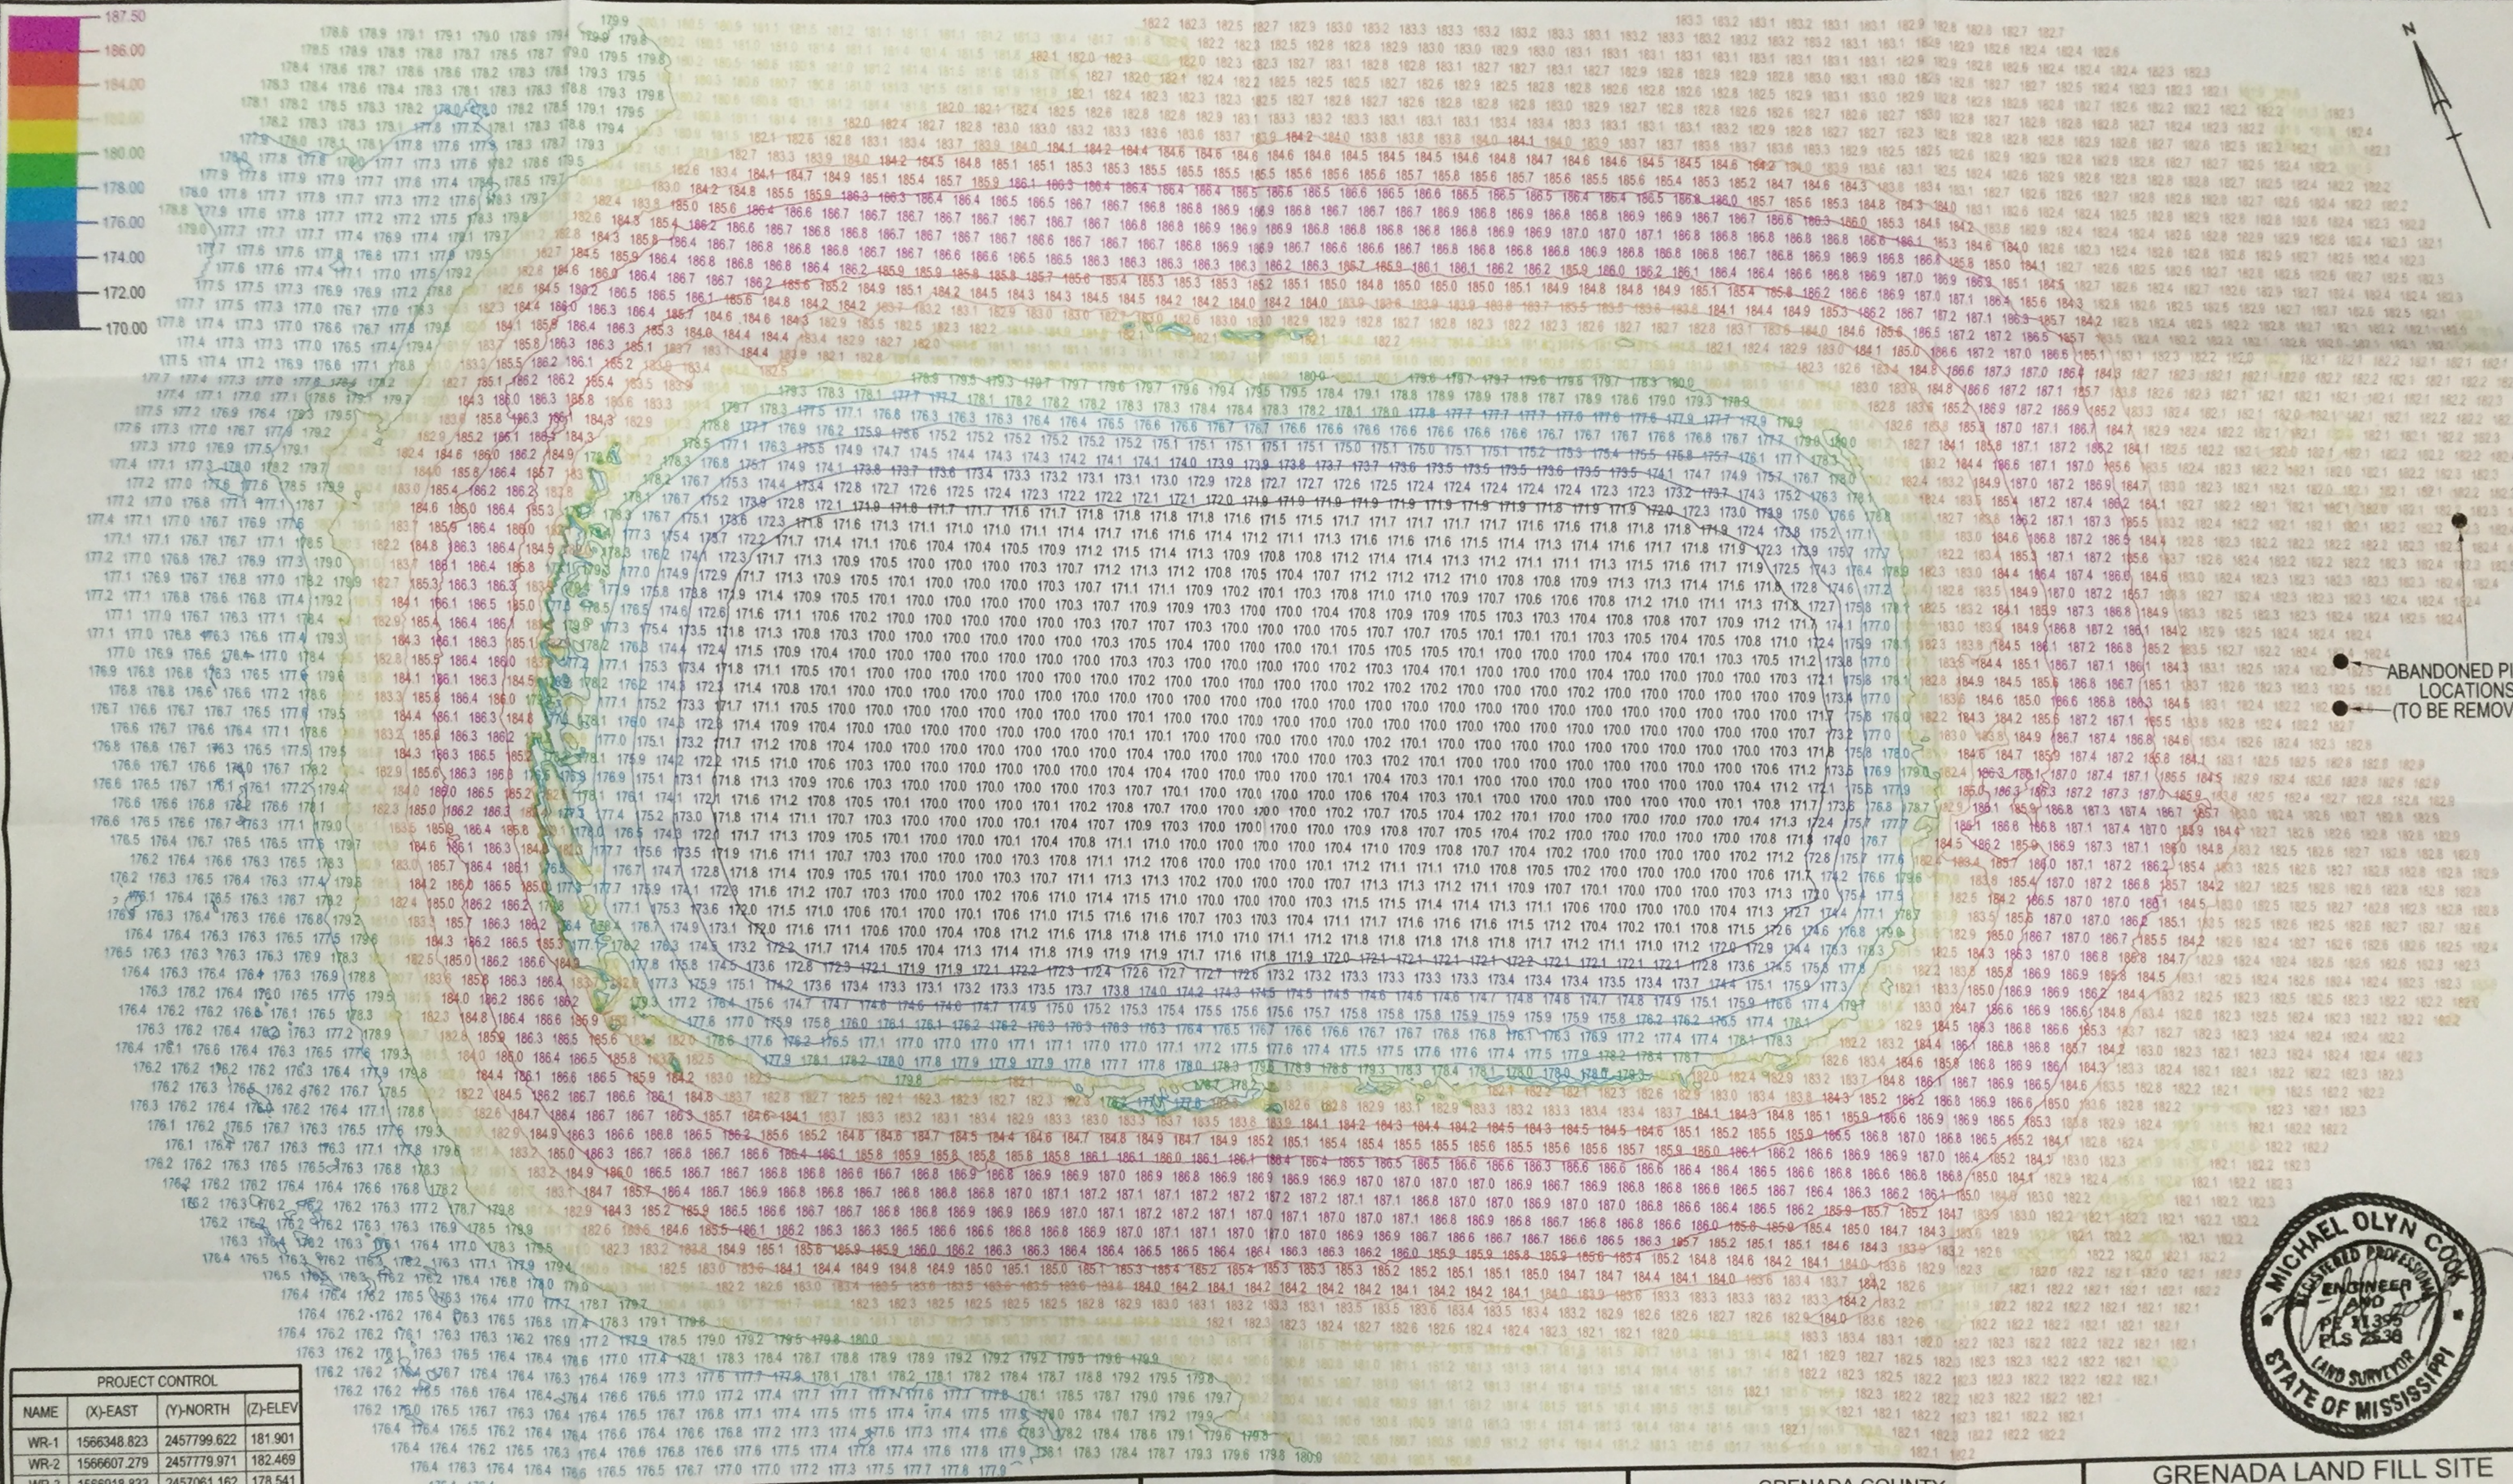
SCALE	AS SHOWN	PLOT DATE	DRAWING	SHEET IDENTIFICATION
DRAWN	DEG	10/13/2010	1 of 10	EMC-10033-01

**GRENADA LAND FILL SITE**  
EXISTING CONDITIONS  
BEFORE CONSTRUCTION  
HARD BOTTOM  
PLAN

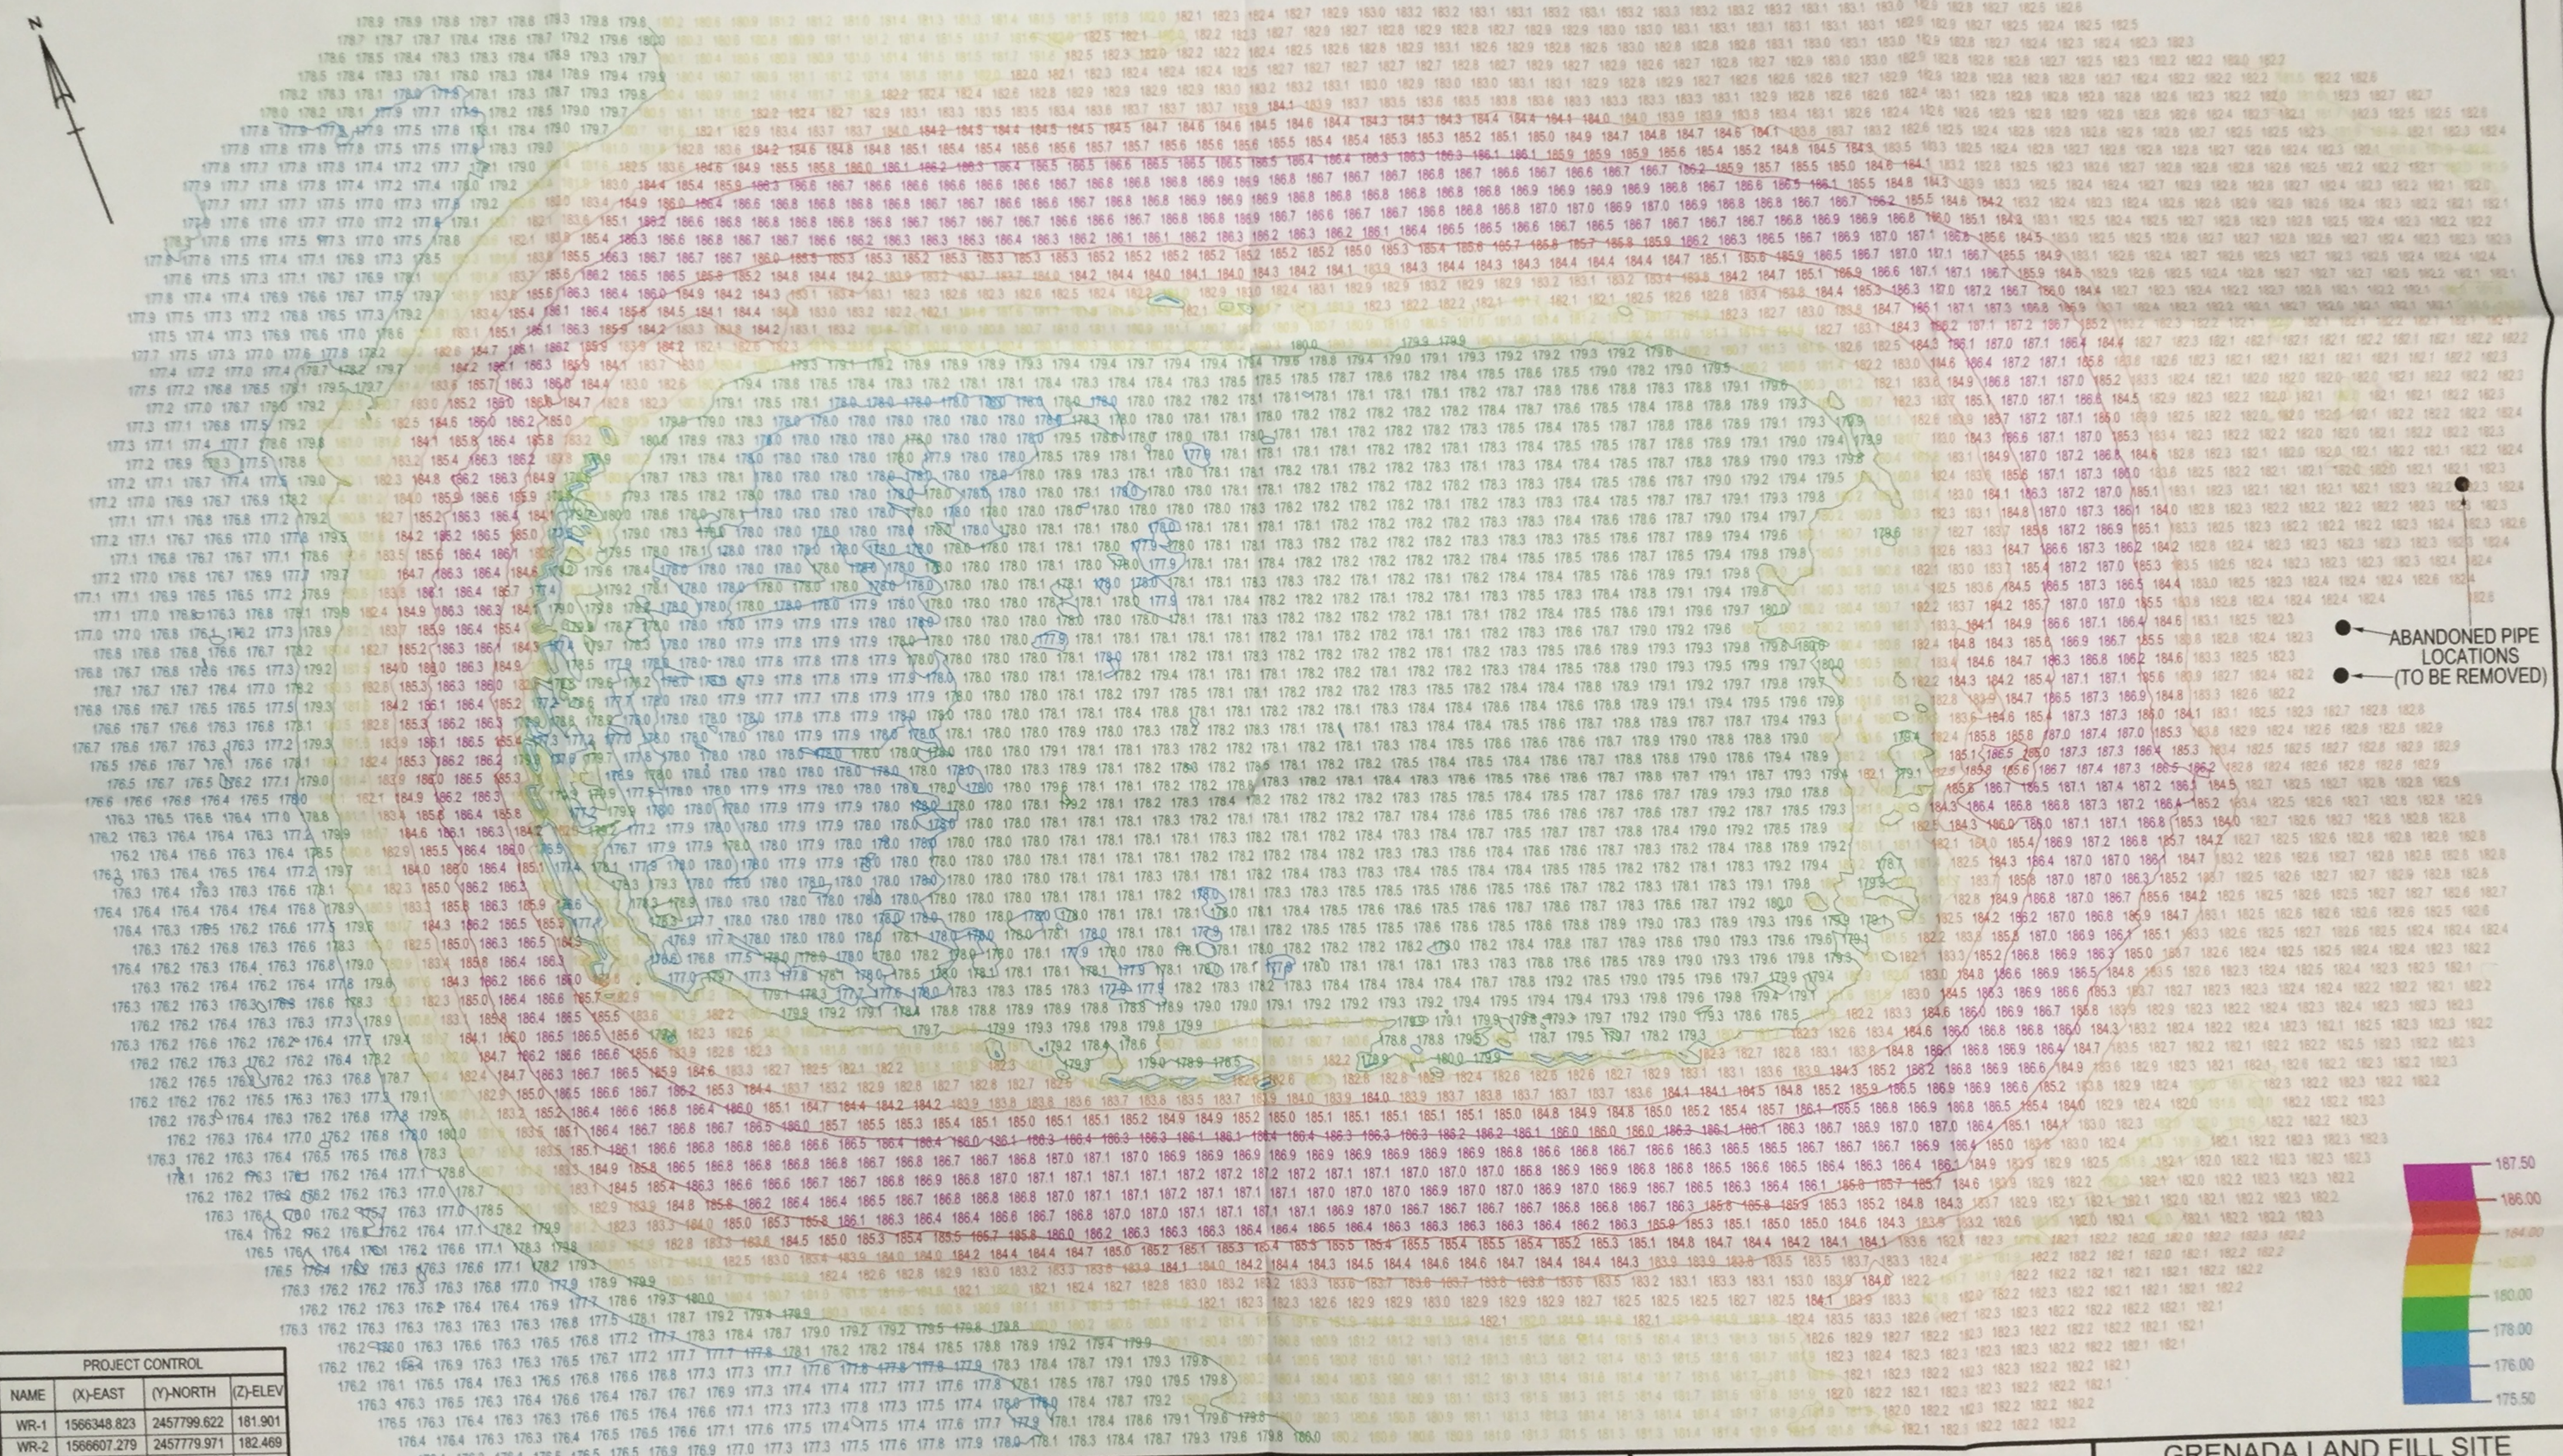
SCALE	AS SHOWN	PLOT DATE	DRAWING	SHEET IDENTIFICATION
DRAWN	DEG	10/13/2010	2 of 10	EMC-10033-02

**GRENADA LAND FILL SITE**  
**EXISTING CONDITIONS**  
**BEFORE CONSTRUCTION**  
**TOP OF SLUDGE**  
**PLAN**

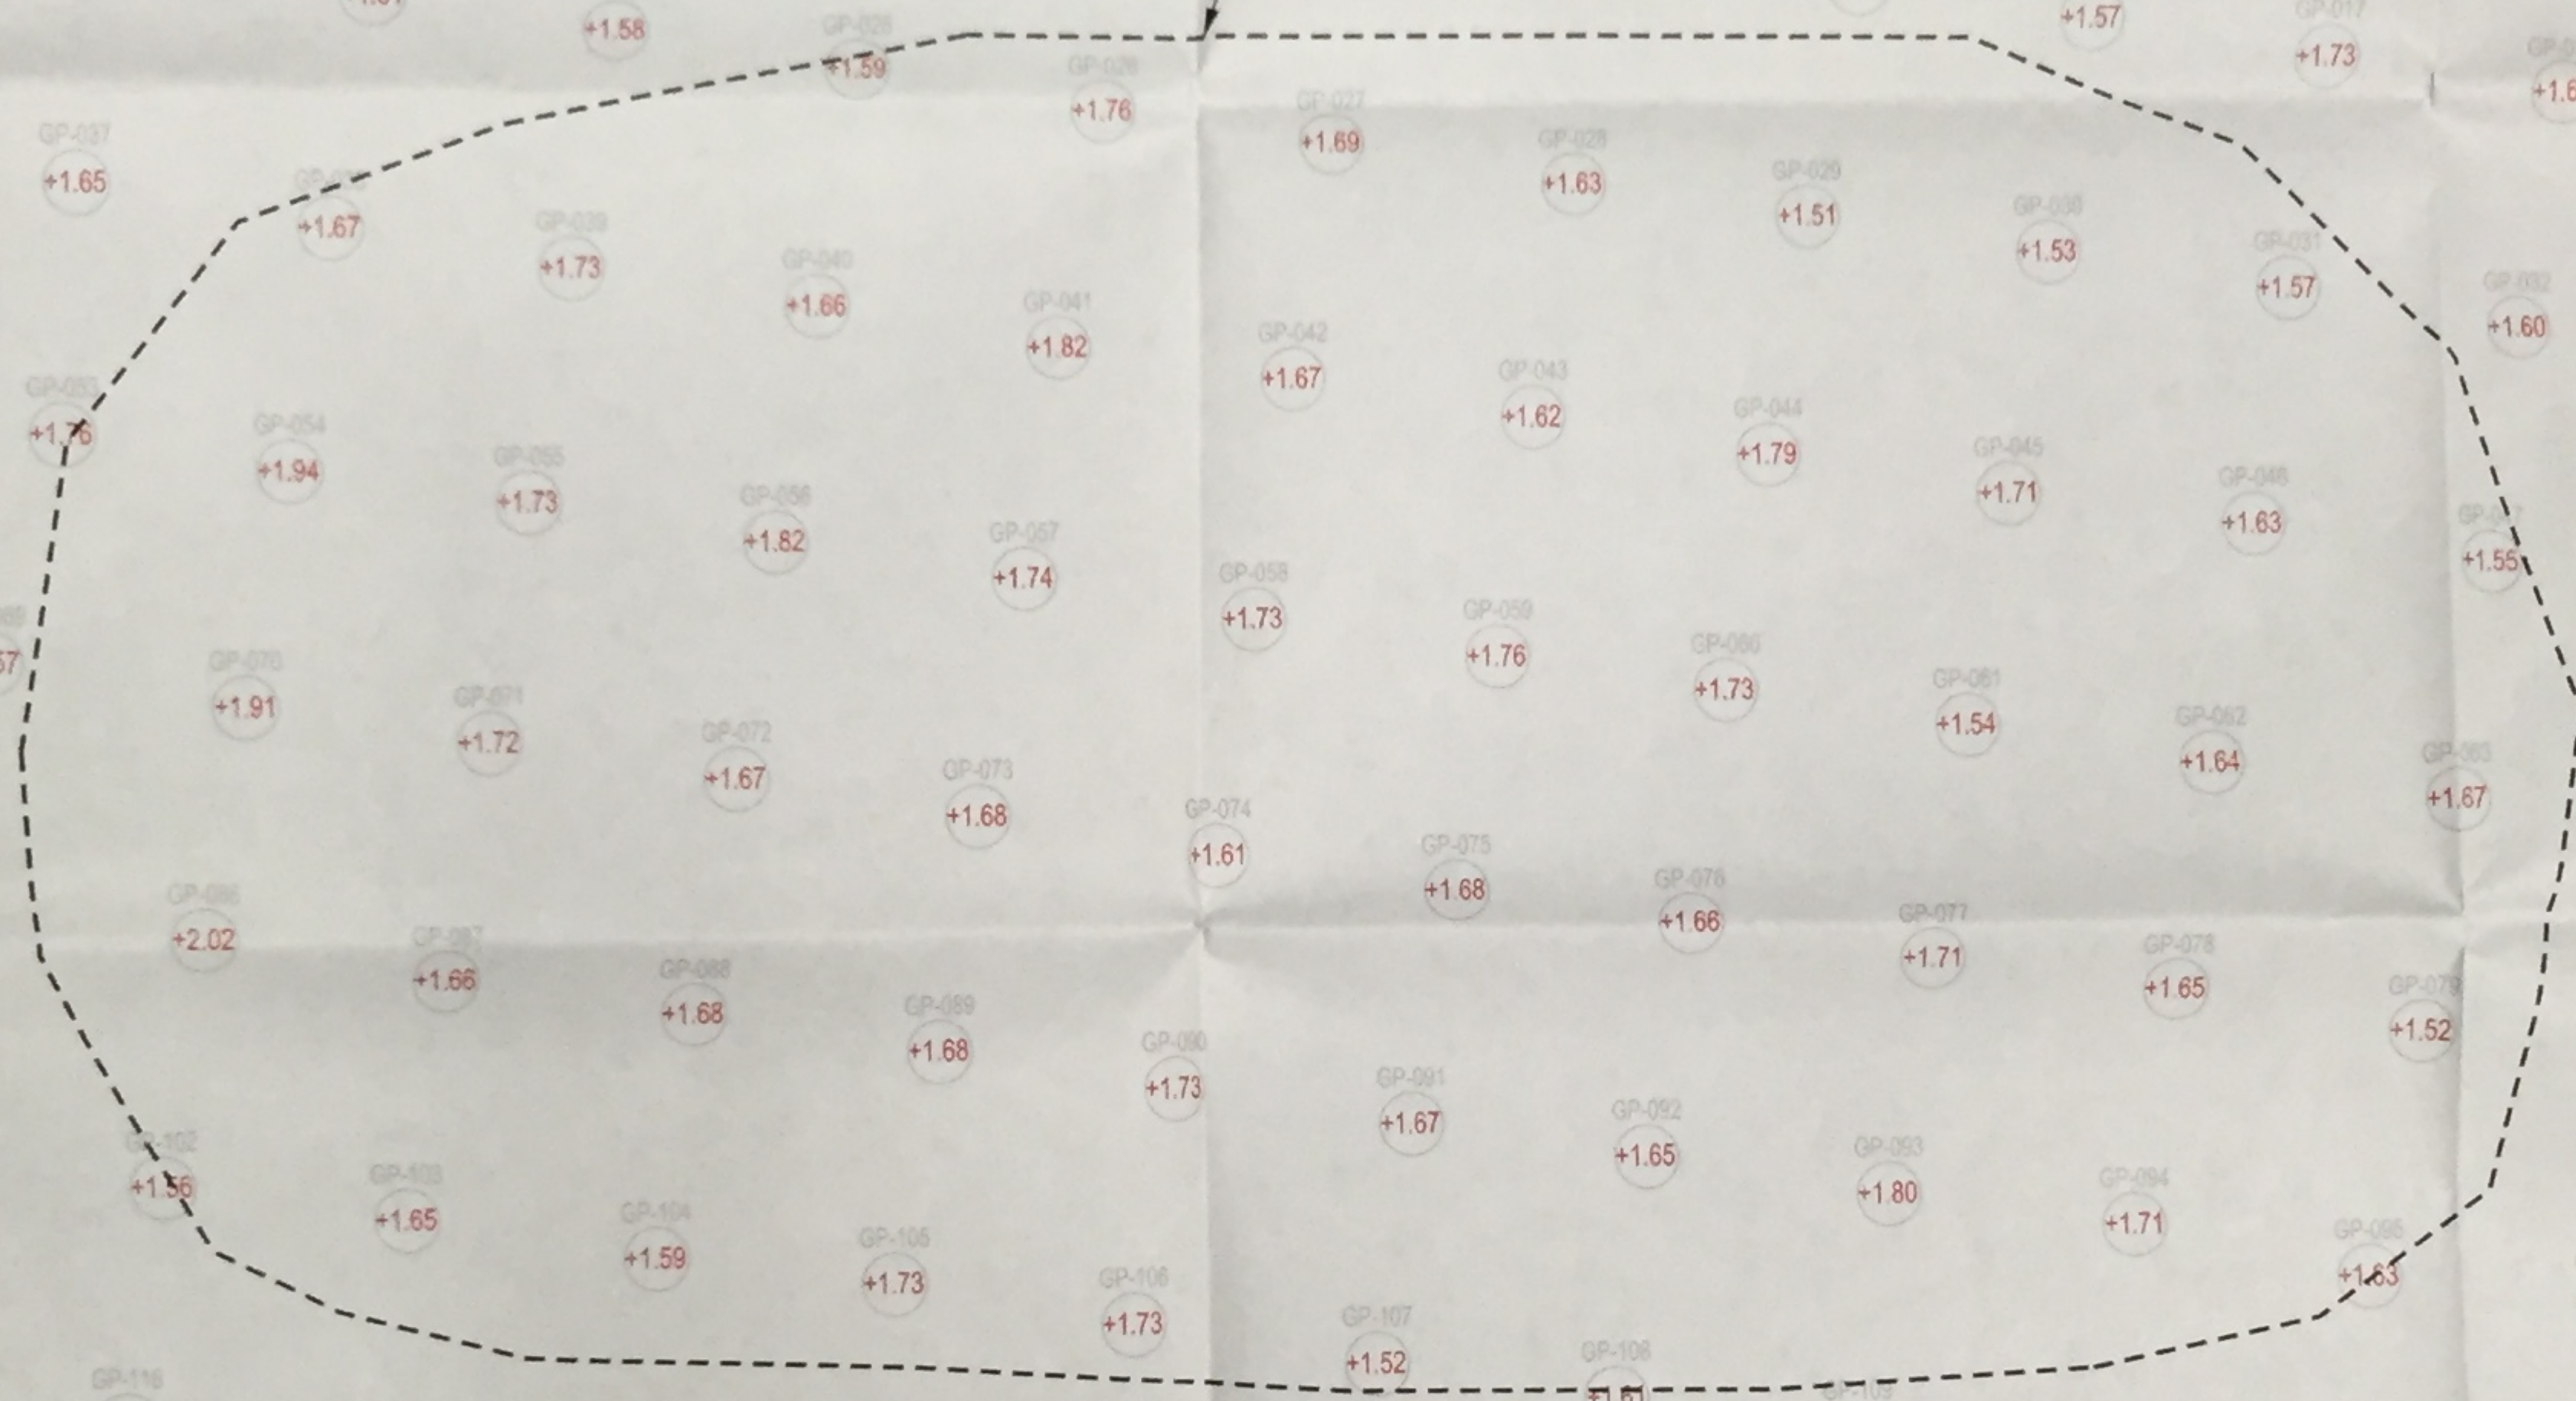
SCALE	AS SHOWN	PLANT DATE	DRAWING	SHEET IDENTIFICATION
DRAWN	DEG	10/13/2010	7 of 10	EMC-10033-07

GRENADA LAND FILL SITE  
AFTER CONSTRUCTION  
SUB BASE THICKNESS  
GRID REPORT  
PLAN

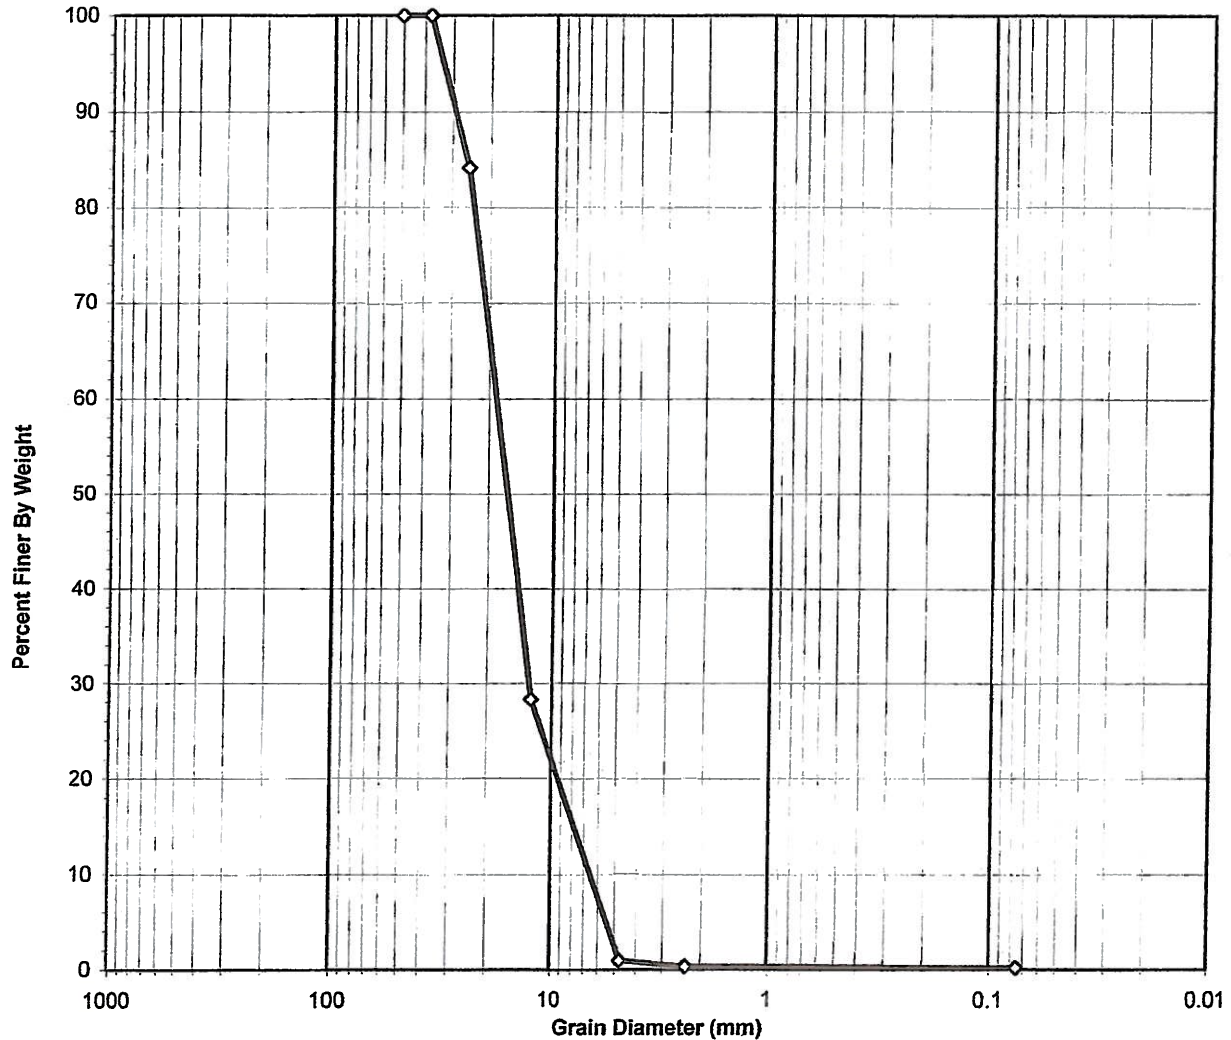
### Confidential Client, Ohio

**USCS Symbol** GP

**USCS Classification** POORLY GRADED GRAVEL

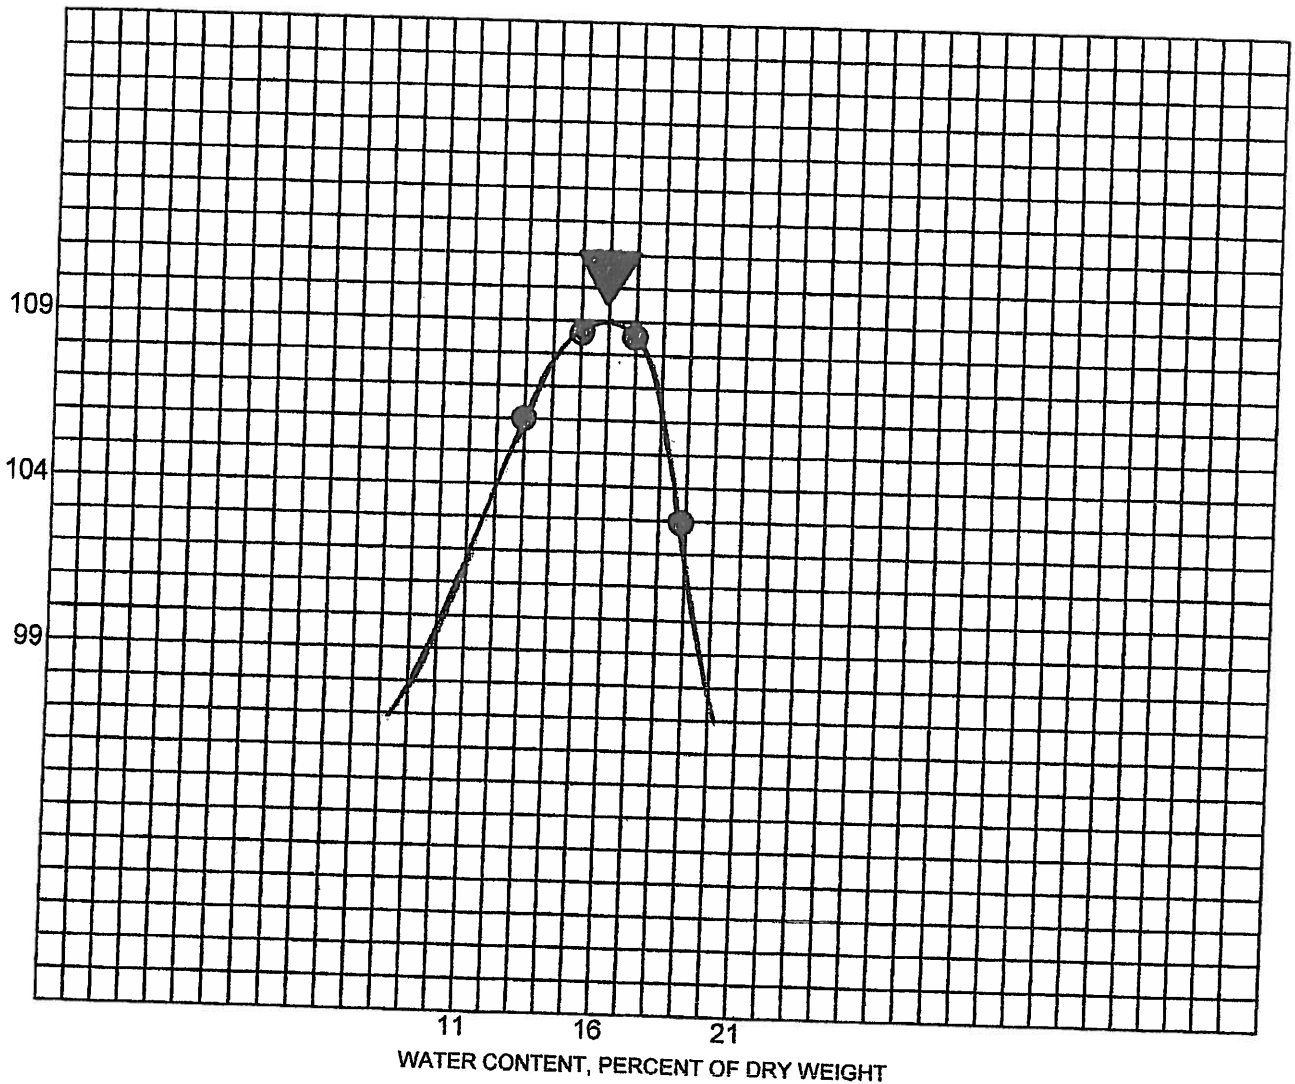
STANDARD D-698		COMPACTION TEST	
25	BLOWS PER EACH OF	3	LAYERS, WITH
12	INCH DROP:	6	INCH DIAMETER MOLD.
		5.5	LB. HAMMER AND

SAMPLE DISCRIPTION	REDISH YELLOW SANDY CLAY
NATURAL WATER CONTENT, PERCENT	
OPTIMUM WATER CONTENT, PERCENT	16.0
MAXIMUM DRY DENSITY, lbs./ cu. ft.	109.0
